# CASUALTY REPORT

[ INCIDENT ]	CREW INJURY/ILLNESS/DEATH	DATE :	10/11/2012
[ VESSEL ]	BULKER		
[ DATE ]	10/02/2012	SEQ.NO. :	2012 012
[ AREA ]	IN PORT		
[ PLACE ]	UK	Originator :	Marine Group

## **SUBJECT: Fatality during mooring operation**

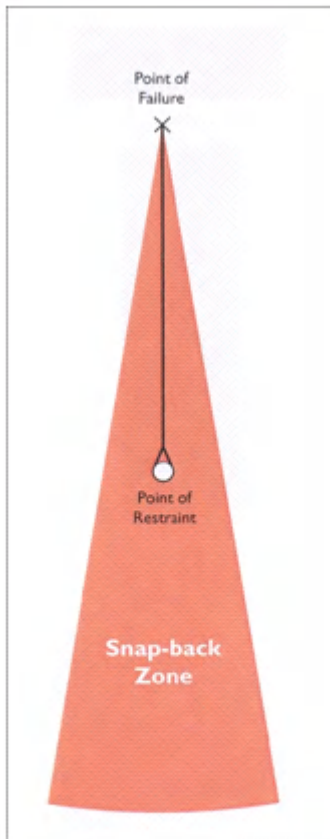
**Figure 1 – A Simple Mooring System Illustrating the Potential “Snap-Back” Zone**

1. Crews are requested to share information about the "Snap Back Zone" shown in Figures 1, 2, and 3.
2. When mooring ropes are under strain, crews should remain clear of the "Snap Back Zone."
3. Crews should stand clear of all wires and ropes under heavy loads even when not directly involved in their handling.
4. It is recommended to paint "Snap Back Zone" on the deck to ensure that crew can visibly see the danger area.

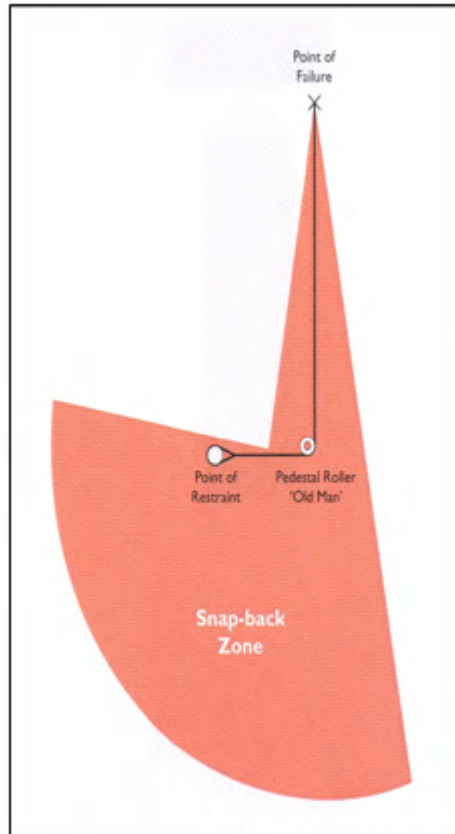
**Figure 2 – A Complex Mooring System Illustrating the Potential “Snap-Back”**

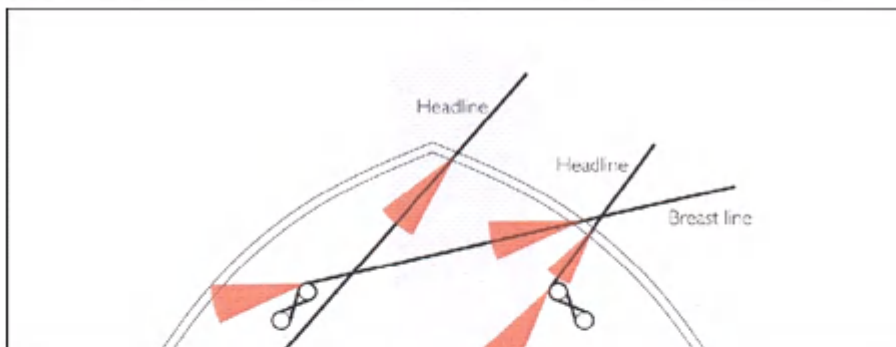
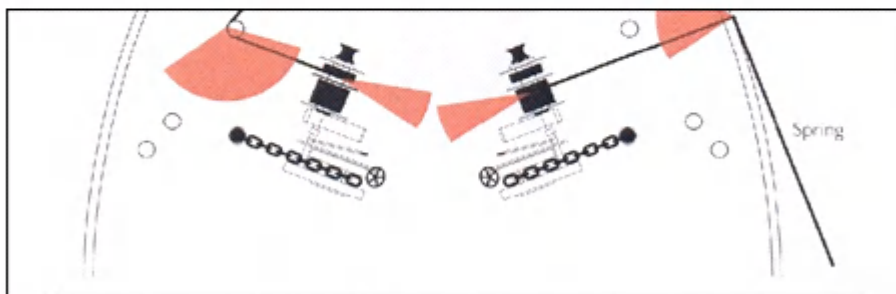
**Figure 3 – An Actual Mooring Deck Arrangement Illustrating Potential “Snap-Back” Zones**
